## Enhancing Easton's Status as a Walkable Community:

## An Evaluation of the Third Street Corridor

A Report of the City of Easton  
Environmental Advisory  
Council – Transportation  
Affinity Circle - July 2009

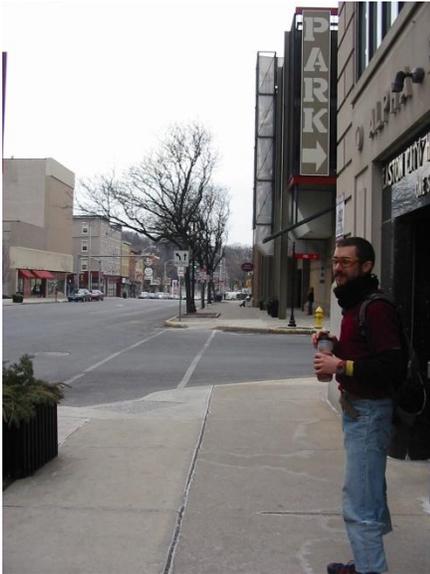
**Figure 2** Intersection of S. Third St. and Pine St., facing south

The crosswalks along Third Street almost universally consist solely of two painted parallel white lines. These markings are not easily and clearly seen from a distance by a motor vehicle driver.

intersection traffic, rather than directing their movements toward the sidewalk on the other side of the street. A prime example of this problem is the crosswalk at Pine Street near the City Parking Garage, depicted in Figure 2, p. 10..

We also recommend that the City alter existing diagonal curb ramps and replace them with perpendicular curb ramps at selected locations such as the intersection of South Third Street and Pine Street to mitigate the risk to pedestrians and disabled persons posed by motor vehicle traffic turning right to enter the city Parking Garage.

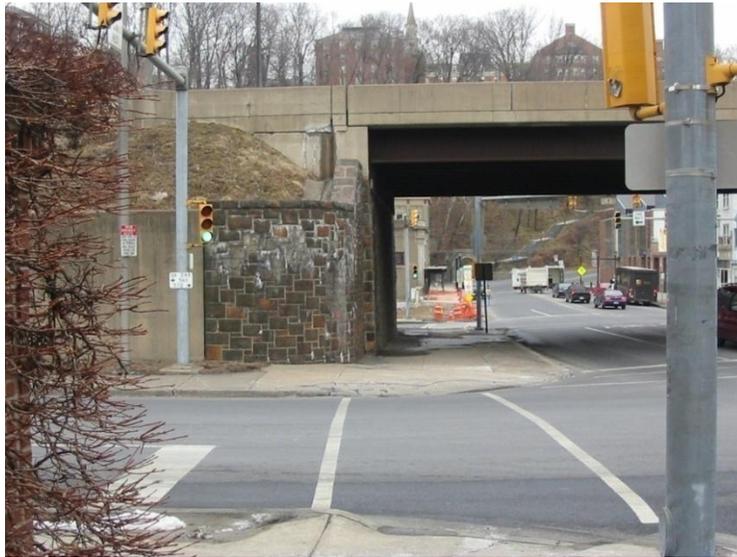
**Figure 3** Intersection of N. Third Street and Bushkill Street, facing north

Because these crosswalks consist solely of two painted lines, good maintenance of the markings is crucial to preserve their visibility. As a general matter, pedestrian crosswalk markings at the intersections of Third Street are in good condition, except for some fading at the intersection of South Third and Ferry Streets. However, we have noted that numerous other crosswalks across streets which intersect Third Street require repainting, especially where road repairs have been performed in the intersections and affected crosswalks have not been repainted. We recommend that the City undertake a visual survey of the crosswalks in the downtown area to determine where repainting or other maintenance is required.

At a minimum, we recommend that the pedestrian crosswalks along Third Street (and along intersecting cross-streets) be examined and repainted where required. At the time of such repainting, we recommend that additional markings be used in addition to two simple white lines to enhance the visibility of these crosswalks; so-called “zebra” or “ladder” striping or similarly high visibility markings should be used whenever feasible.

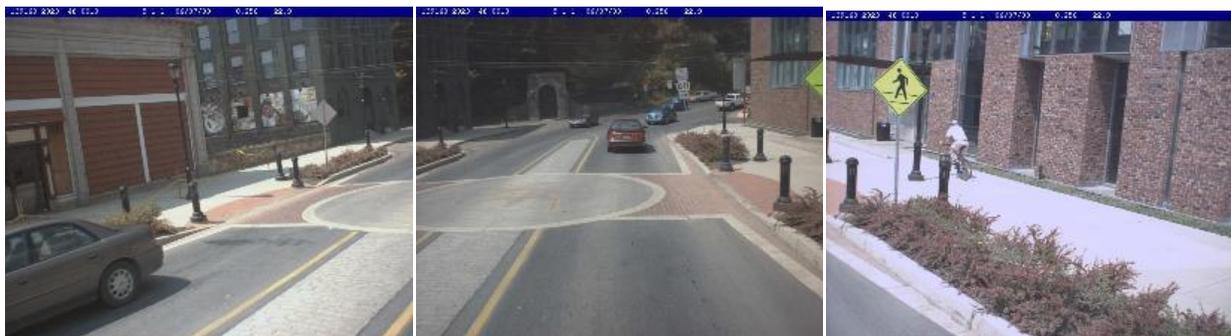
**Figure 4:** 200 Block of North Third Street (northerly view)

In contrast with the generally-used parallel lines, the crosswalk in the 200 block of North Third Street is a high-visibility pedestrian crosswalk with decorative paving and lampposts. The crosswalk is shown below in Figure 4, a series of still frame captures from the PennDOT State Highway Video Inventory (northerly direction of view).

We recommend that consideration be given to replacement of the simple pavement markings with installation of the type of improved crosswalk within the 200 block of North Third Street (depicted in Figure 4), whenever feasible. This is especially applicable due to its characteristics as a heavily-traveled thoroughfare and fairly dense, mixed use streetscape for which the City wishes to encourage pedestrian traffic. This is true particularly because of the retail businesses within this Street Corridor Enhancement Overlay Zoning District and its location (subject to final alignment decisions) along the Bushkill Creek Heritage Trail. While we recognize that City budgetary constraints may cause other roadway improvements to command a higher priority, these recommendations should be implemented where such roadway improvements are proposed for crosswalk intersections.

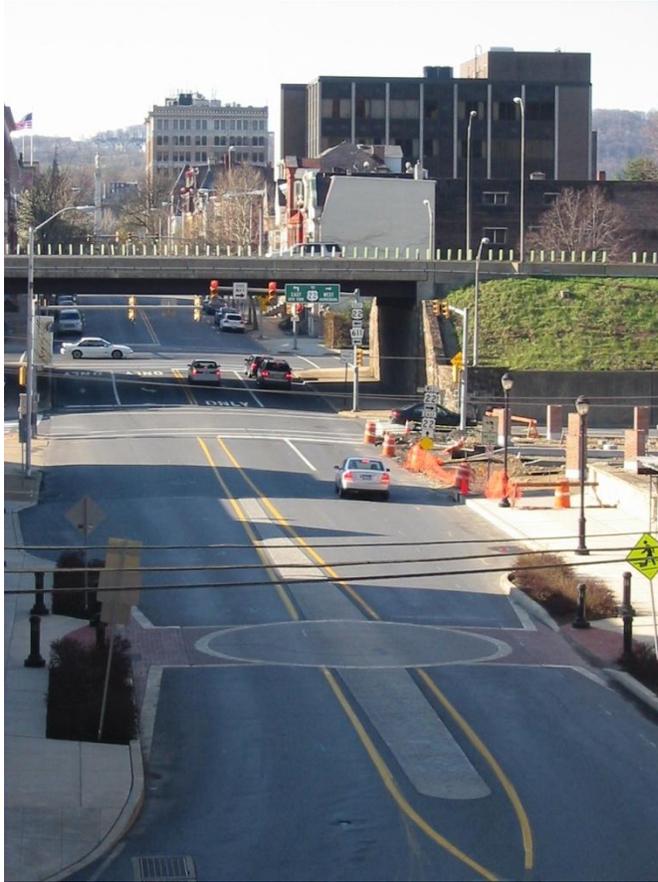
**Figure 5: 200 Block of North Third Street as viewed from Lafayette College steps**

The crosswalk shown with its overall context within the corridor is shown below, in Figure 5:

In addition, the crosswalk is also clearly identified with a standard diamond shape pedestrian crosswalk sign (W11A-2). It is obviously important for motor vehicle operators to recognize the existence of a crosswalk sufficiently far in advance of the crosswalk to influence driving behavior so that they are in a position to yield the right of way to pedestrian traffic if required. The simple markings of two parallel white lines perform this function minimally and perfunctorily.

The City's use of two simple painted parallel white stripes unfavorably compares with the "zebra" or "ladder" markings for pedestrian crosswalks such as those depicted in Figure 5. The "zebra" or "ladder" markings are significantly more visible and have been

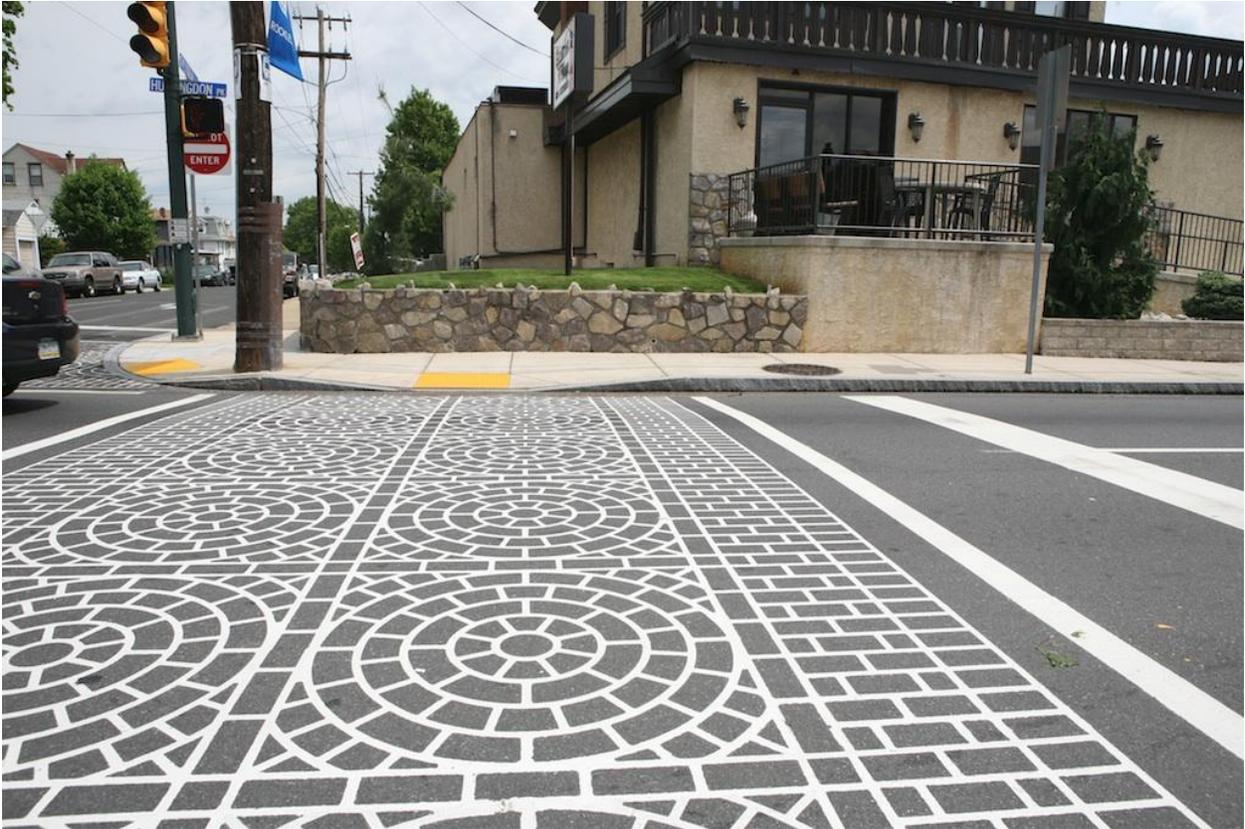
**Figure 6: Decorative Crosswalk near Bryn Athyn, PA**

The FHWA now recommends that pedestrian crosswalks be designed "as enhanced crosswalks that combine highly visible markings (ladder striping) with additional pedestrian treatments, such as shorter crossing distances, traffic calming and medians". FHWA, *Designing Sidewalks and Trails for Access, Part II of II: Best Practices Design Guide, Chapter 8, Pedestrian Crossings, Section 8.5.3, "Recommendations for Enhancing Pedestrian Safety and Access"*, accessed at <http://www.fhwa.dot.gov/environment/sidewalk2/sidewalks208.htm>. Indeed, while uniformity of message through consistent visual design should not be ignored, we note that crosswalks need not be purely functional in appearance; highly decorative crosswalks could be designed and painted, such as the one depicted in Figure 6:

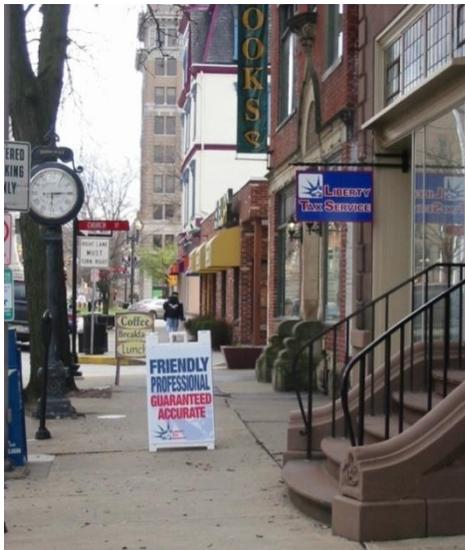
**Figure 9: N. Third Street (0-100 block), facing south**

We also observed some points along Third Street in which the pedestrian travel path was effectively reduced due to projections into the footpath, such as newspaper boxes, sandwich boards, and other objects. In some cases, although almost certainly inadvertent, the obstructions would preclude wheelchair movement. An example (since corrected) is depicted in Figure 9. Property owners should be reminded that they must avoid sidewalk obstructions which make the path of travel along a sidewalk inaccessible for wheelchair passage.

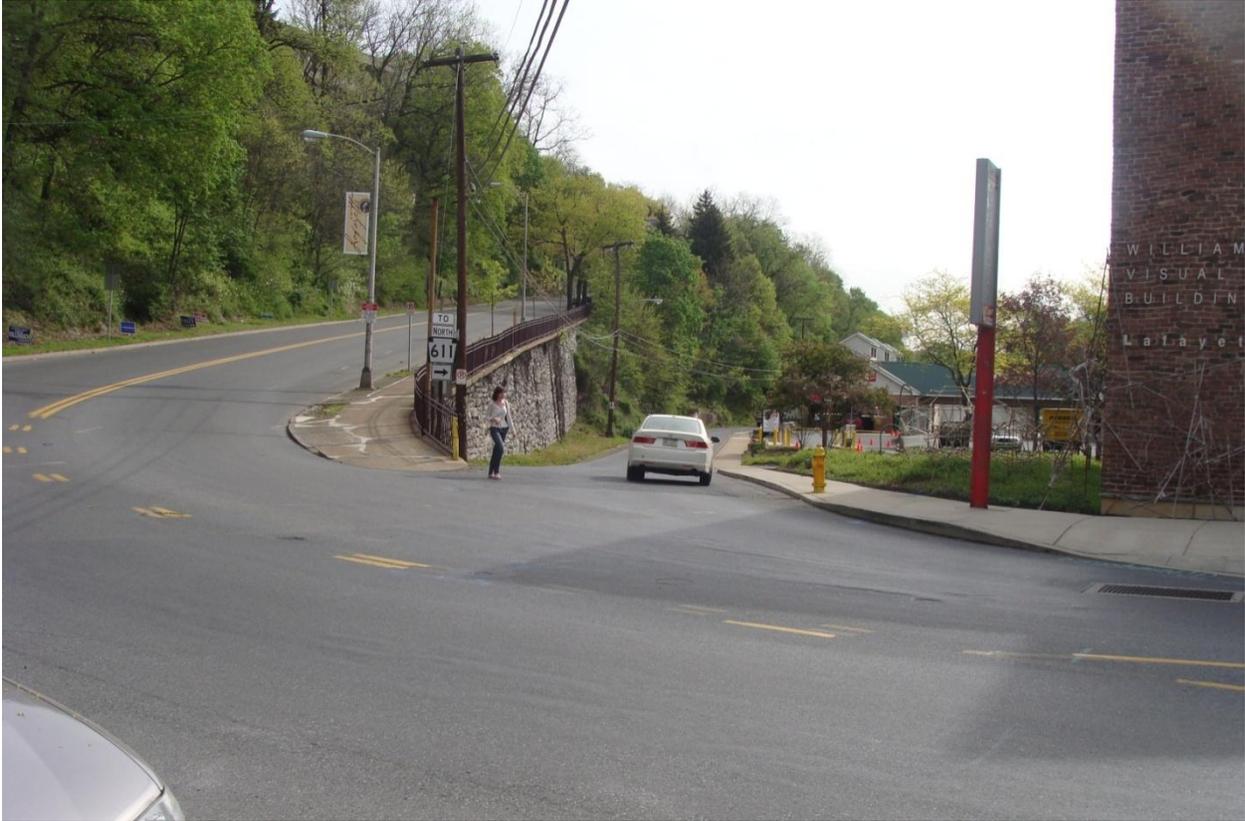
**Figure 10: College Avenue and Bushkill Drive**

Pedestrians walking in a northerly direction along the east side of North Third Street to reach the sidewalk along College Avenue are forced to cross Bushkill Drive under conditions which are made difficult and feel insecure due to a combination of factors. See Figure 10. Because of the acute angle of the intersection, it is often impossible to determine whether motor vehicle traffic along North Third Street toward College Avenue will proceed up College Avenue or whether it will enter Bushkill Drive. This problem is exacerbated by the relatively high speed of motor vehicles at that location, the failure of drivers to use turn signals signaling a right-hand turn at that location if intending to turn onto Bushkill Drive, and the absence of a visible crosswalk (the existing crosswalk is so faded as to be invisible to motor vehicle traffic) which would visually remind drivers that pedestrians may be crossing the street at that location.

We recommend that the City evaluate additional traffic calming measures for traffic turning into Bushkill Street including curb extension and/or decreasing the curb radius at that location, and enhancement of the visibility of the pedestrian crossing.

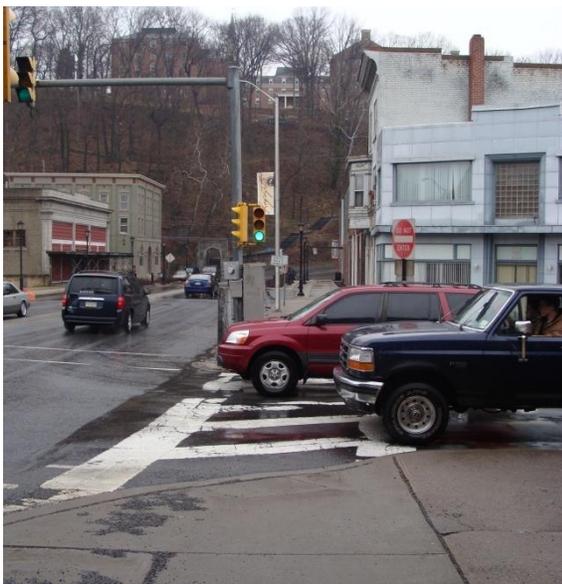
**Figure 11: Intersection, N. 3rd St. and bottom of Route 22 westbound exit ramp (at Snyder St.)**

Ideally, the highway-scale “overhead” traffic signalization (see, e.g., Figures 11, 12) would be replaced by lower, “car-level” signalization placed at the corners, so that a driver would be forced to stop further back from the intersection in order to see the traffic signals. These signals would appear closer to the drivers’ eye-level, encouraging drivers to look at “pedestrian-level”, and see pedestrians, rather than looking high above eye level.

At the intersection of North Third Street/Snyder Street, traffic exiting the Route 22 westbound off-ramp is permitted to turn right on red. As a consequence, traffic frequently enters the pedestrian crosswalk at that location and barely slows down to proceed north on College Avenue, creating a risk of collision with pedestrians lawfully entering the crosswalk. The right hand turn-on-red designation should be reviewed and reconsidered if feasible. Another possibility is to make the intersection curve/curb more flared, with a smaller corner radius, thus “shorten[ing] crossing distances for pedestrians” and “compel[ing] motorists to slow down as they negotiate [the] corner” and “discourag[ing]

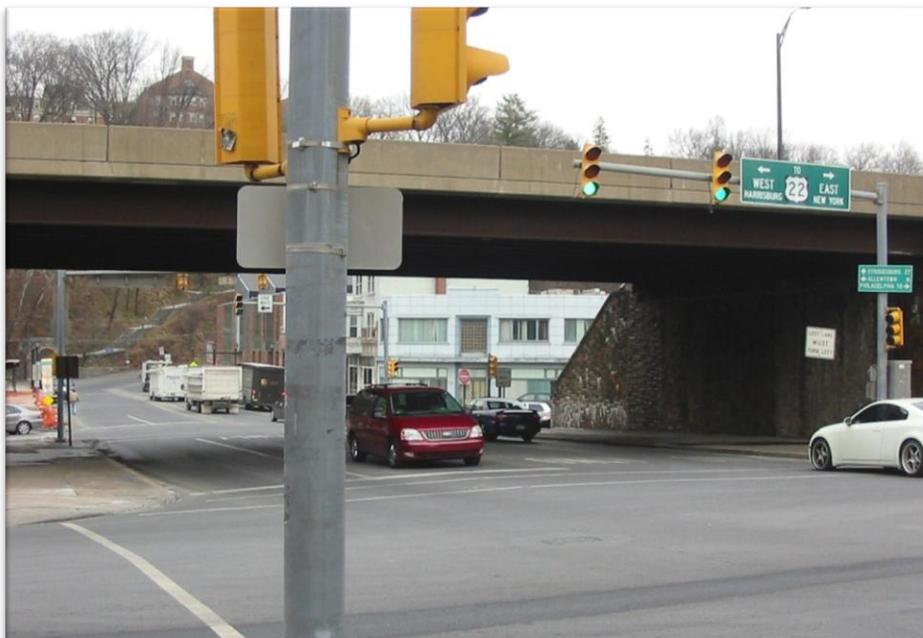
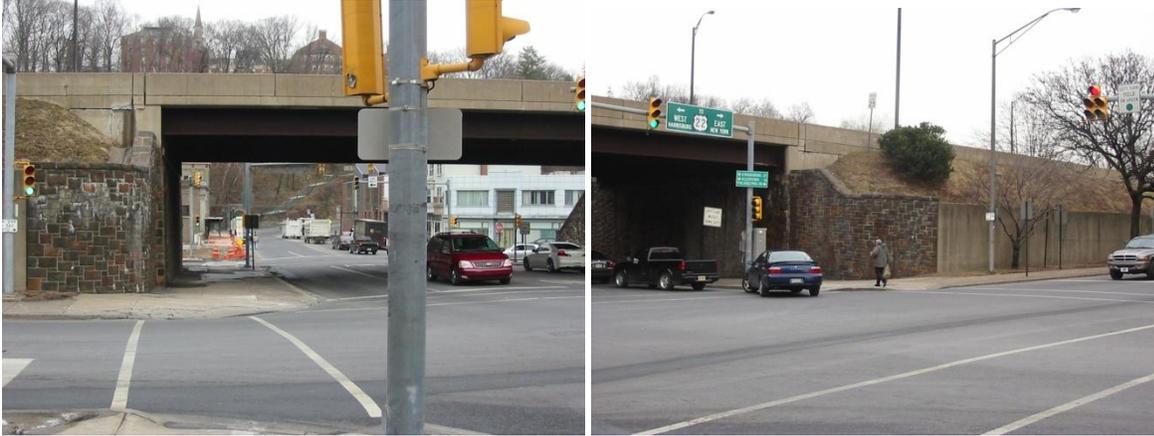
The dominant presence of the Route 22 overpass crossing Third Street creates an imposing visual, physical and psychological barrier, which separates the downtown area from the North Third Street/College Avenue area. It is easy to see from the aerial photograph of this area (Figure 12) how the overpass simply cuts through Third Street, physically dividing the community and interrupting the sense of place and continuity. The overpass abutment and elevated roadway terrain essentially form a huge wall which is interrupted by a “tunnel” which is itself uninviting to pedestrians and engenders a sense of isolation. In one sense, the question is a simple one: does this feature of the cityscape say, “please come in; you are welcome”, or “don’t come here”? Under certain conditions such as nighttime, travel through the “tunnel” can feel desolate and foreboding.

Figure 13 - North Third Street and Bushkill St (facing northward)

**Figure 14: North Third Street and Bushkill Street (facing north, northeast).**

The blank, high barrenness of the concrete and iron overpass further accentuates the sense of isolation and lack of human scale as one passes beneath it. At nighttime, there is inadequate illumination for pedestrians walking beneath the overpass, provided by a single (sodium?) light fixture and spillover from street lighting. The sense of physical isolation and the lack of good lighting engender a sense of insecurity. This does not encourage pedestrian traffic from the College Hill area to a nightlife downtown. In addition, the lack of a protective barrier between pedestrians walking through the tunnel and motor vehicles traveling along Third Street creates an insecure feeling. We therefore recommend that a series of bollards be placed along the edges of the sidewalks through the tunnel to protect the pedestrians and to create a feeling of greater security. Ideally, they would be lighted for nighttime pedestrian travel.

Visual and aesthetic improvements could reduce the sense of the structure as an unwelcoming barrier. For example, the use of color, plantings, light and public art could mitigate the barren visual presence of the abutment and tunnel. The potential for public art to enhance pedestrian-friendliness and to create and shape a positive sense of place is discussed in more detail below.

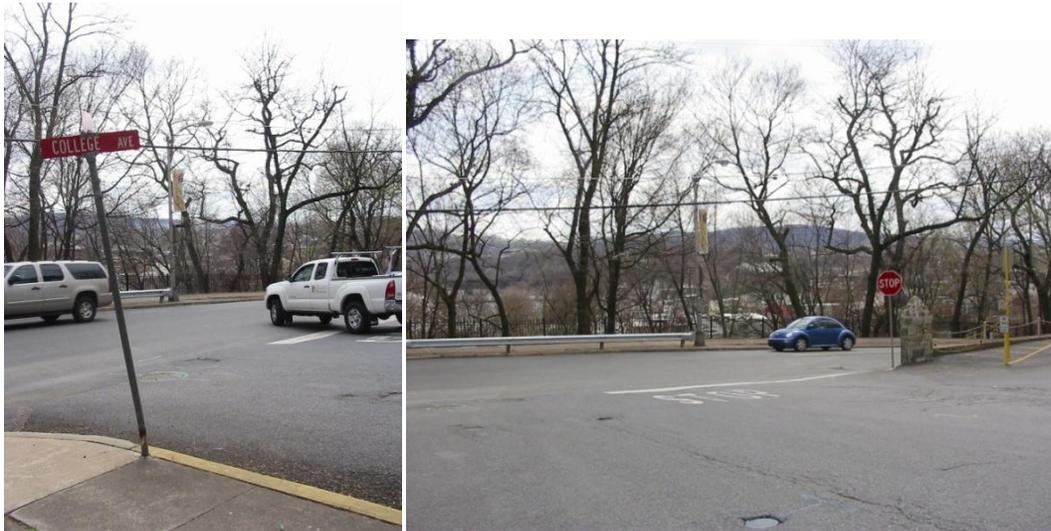
**Figure 17: College Avenue and McCartney St.**

The pedestrian walking down College Avenue is challenged not merely because of the sense that at the bottom of the steep grade he or she will be greeted by an unfriendly barrier-like physical environment but also because the experience itself along the way is not particularly pedestrian-friendly. Pedestrian travel is only possible on one side of the roadway, as the sidewalk only exists on one side and traffic routinely travels on the other (in a downgrade direction) at speeds far too high to make walking along that side safe. For a pedestrian traveling downtown from College Hill via McCartney Street (the only other street on College Hill intersecting College Avenue), the very beginning of the journey is troublesome. There is no uninterrupted sidewalk connecting such a pedestrian's travel down McCartney Street and thence along College Avenue. To reach the sidewalk down College Avenue, a pedestrian must cross College Avenue without any marked crosswalk, at a location not far distant from an acute and blind curve.

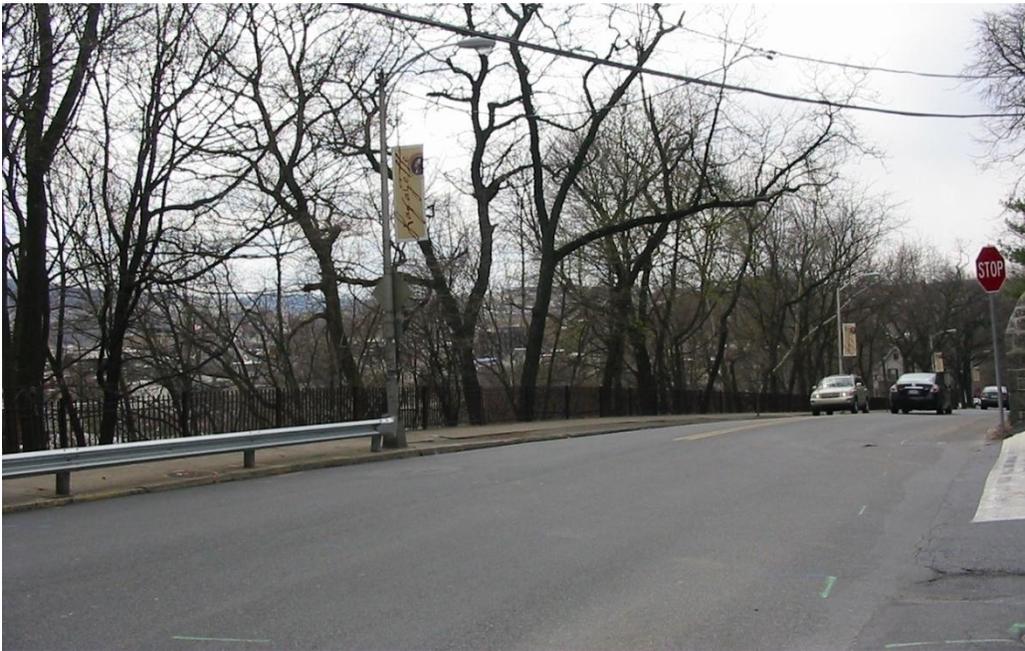
**Figure 18 - College Avenue at intersection with McCartney St., facing southwest**

The open expanse on the [eastern] side of College Avenue creates a somewhat interesting vista. However, this openness precludes any sense of “visual enclosure” which actually enhances walkability.<sup>11</sup> Pedestrian- and Transit- Friendly Design: A Primer for Smart Growth, Reid Ewing, Smart Growth Network, p. 11. See photograph (Figure 18) below.

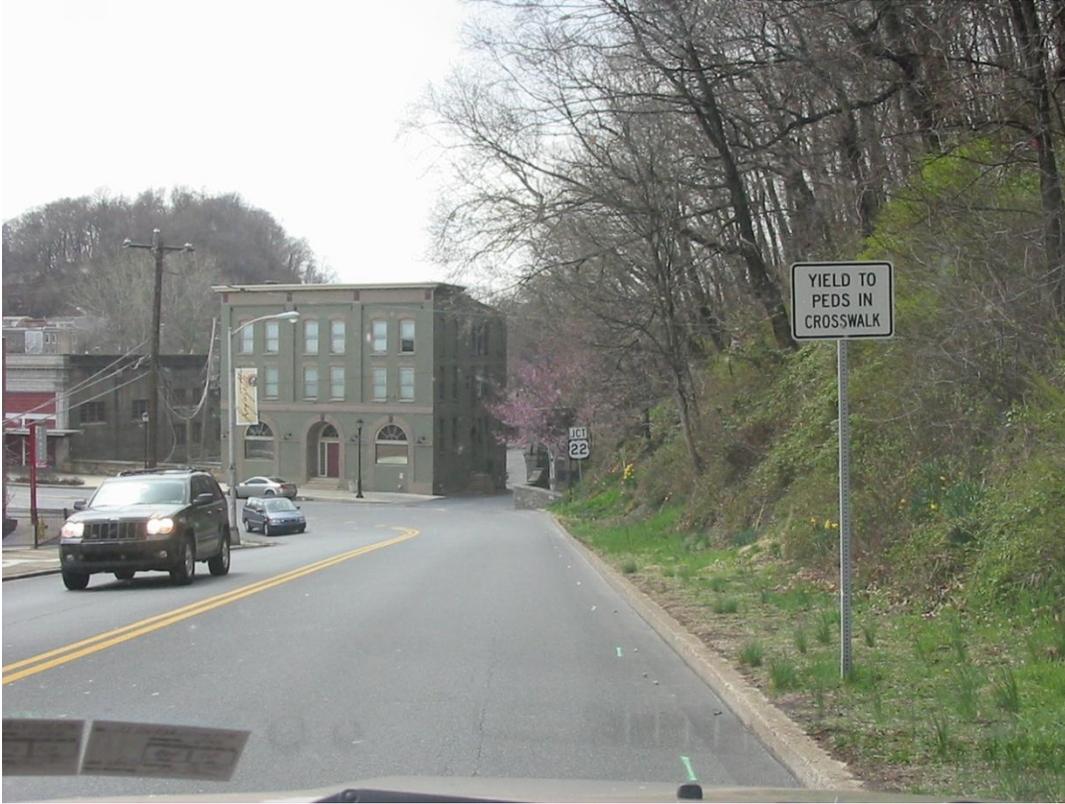
**Figure 20 - College Avenue traveling south**

We have previously mentioned the decorative crosswalk at the base of College Avenue. Because the crosswalk is at the bottom of a long steep downgrade and around an essentially blind curve, there is signage along College Avenue which is intended to alert motor vehicle drivers to the upcoming crosswalk. This signage is depicted in the photograph below:

We believe the signage announcing the crosswalk needs to be improved, or additional signage provided. The literal message – “yield to peds in crosswalk” is fine. However, the existing signage is inadequate in size and visual effect. The message should not be merely in text; a standard yellow pedestrian sign should be placed in an appropriate location along College Avenue above the crosswalk. As the photograph shows, the text sign refers to a crosswalk which is not yet in sight: it is further down the hill, unseen, around an acute curve to the left. Because the crosswalk is not visible until exiting the curve, drivers have a very short distance (approximately 150 feet) to visually identify the crosswalk before reaching it. At 20 mph (a speed greater than the posted 15 mph curve limit, but a speed routinely observed), this is about 5 seconds. Drivers unfamiliar with the area will have no understanding that there is a crosswalk much further down the road, around the upcoming curve. There are old, worn crosswalk markings at the bottom of the hill near the Lafayette College gate which a motor vehicle driver may (incorrectly) assume is the crosswalk to which the sign refers. The sign would be more effective if it were accompanied or preceded by additional or more visible signage such as a sign which said “Crosswalk Ahead”, or a similar message. Another potential measure would be “Ped X-ing Ahead” signs along College Avenue with flashing yellow lights that are activated by a signal button at the crosswalk itself.

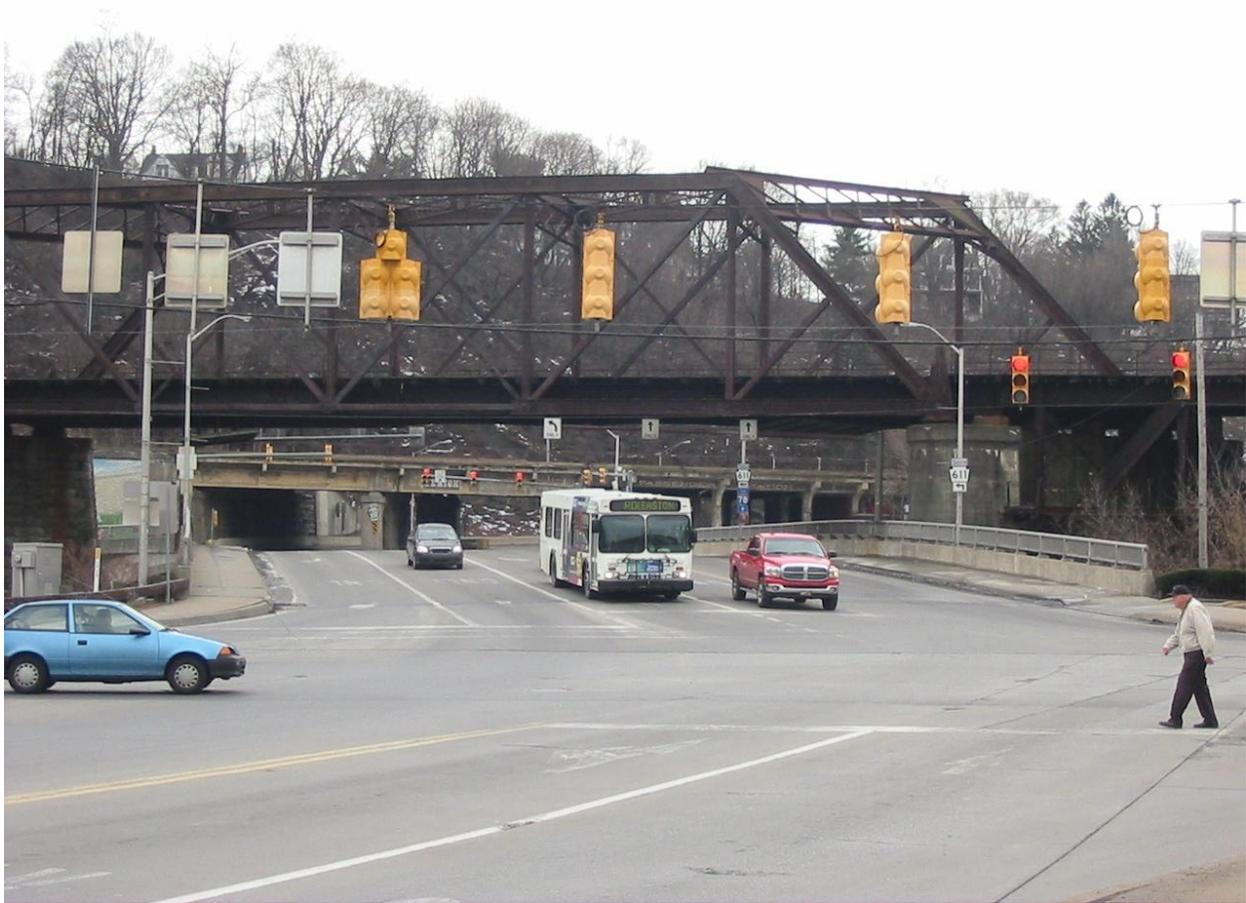
**Figure 22 - Intersection of South Third Street and Larry Holmes Drive**

It is apparent that the design of this intersection is utterly insensitive to the needs of pedestrians. The plight of a pedestrian attempting to cross this wide (six lanes) and unforgiving intersection is illustrated below:

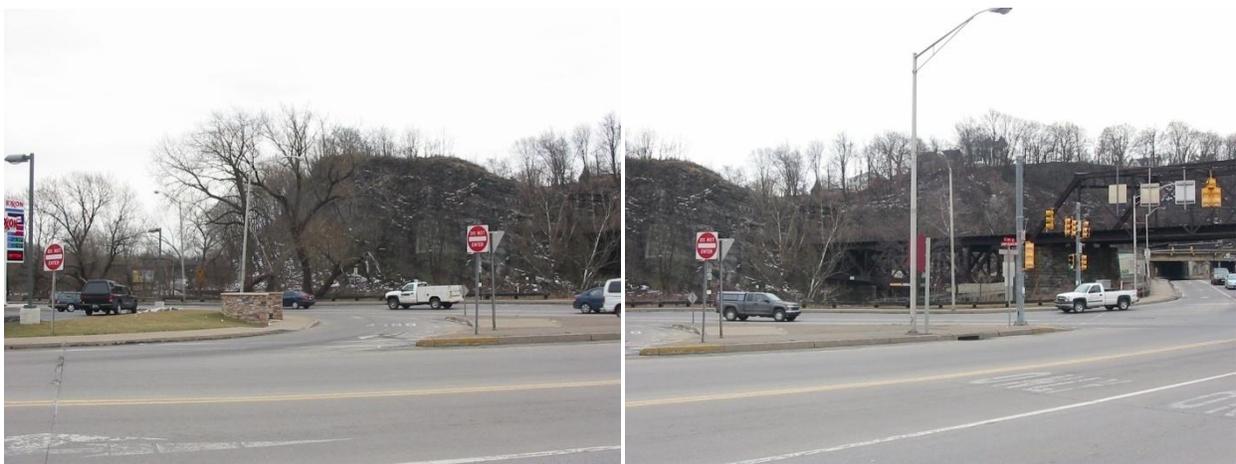
**Figure 23 - Intersection of South Third Street and Larry Holmes Drive (two views)**

The daunting complexity of the intersection is further illustrated:

There are other problems of detail at this intersection, including a mismatch between the pedestrian crosswalk and the curb ramps near the Exxon station (they simply do not line up) and the visually bare and unattractive island depicted in Figure 23. In addition, the wide "driveways" through the Exxon station have no vehicle lane markings and poor directional markings. The city should consider requesting the owner of the property to place planters or other visually attractive markers to guide traffic in and out of the station and to mitigate the appearance of a vast expanse of asphalt.
